## Manotick Walk Audit January 10, 2018

### Introduction

The Manotick Village Community Association (MVCA) with support of the Council on Aging undertook a walkability survey of selected streets on January 10, 2018 from 1000-1100hrs. We had six participants ranging in age from 40s - 87 along with a Public Works - Environmental Services representative. We used the All Season Age-Friendly Pedestrian Safety and Walkability Checklist developed by the Council on Aging to assess the **Safety , Accessibility , Convenience & Connectedness and Comfort & Attractiveness** of the sidewalks on our selected route. This audit is one tool to use in engage our councillor , city staff, businesses, institutions and our citizens to identify walkability and access issue resulting in short and long-term improvements to year safety and accessibility in Manotick. This survey conducted on this date is specific to only one part of the Manotick core. It is planned to do more surveys in other areas identified with walkability issues and as well in other seasons.

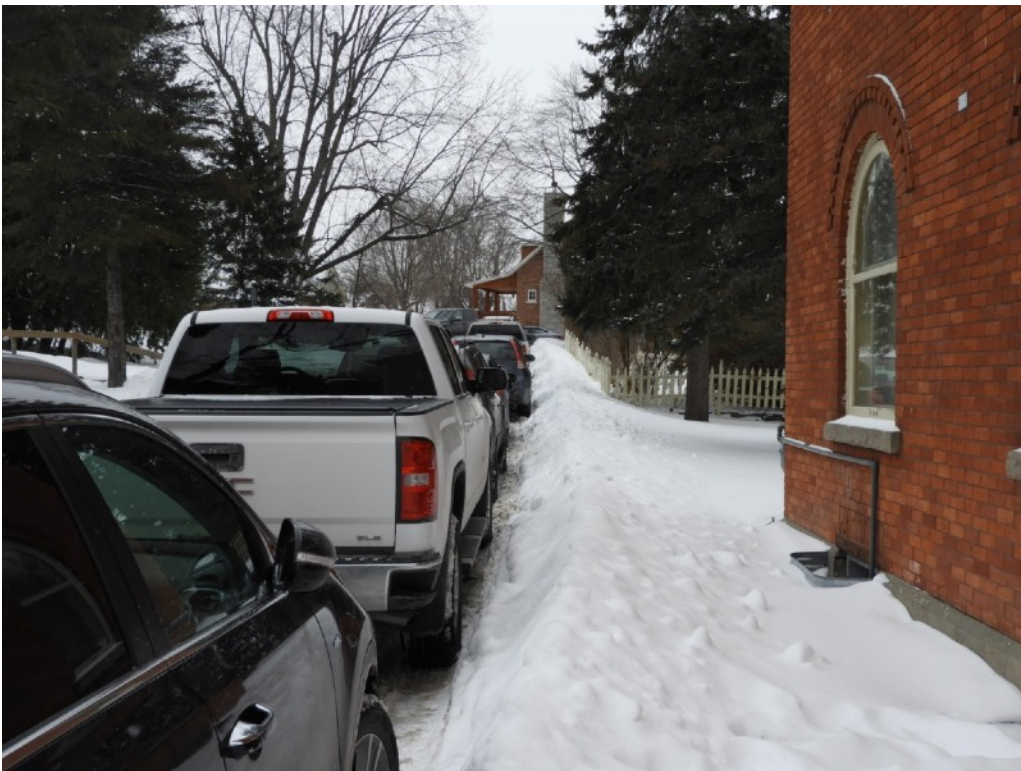
Between Mill and Tighe St on Dickinson St, the sidewalk is covered with snow having never been shovelled. The street is very narrow as parking is allowed on the west side. One has to watch for vehicle traffic and dart in between the parked vehicles to avoid being hit. At the corner of Mill and Dickinson St , there is a pick up place for school buses. Although this was a winter audit, it was pointed out that in the summer, there are significantly more people due to day camps for children , visitors to the Mill , the market and special events. This is a hazardous street.

Dickinson St between Mill and Tighe Streets. Sidewalk is buried and has never been shovelled.

Ban parking or have vehicle parking on the opposite side and shovel the sidewalk.

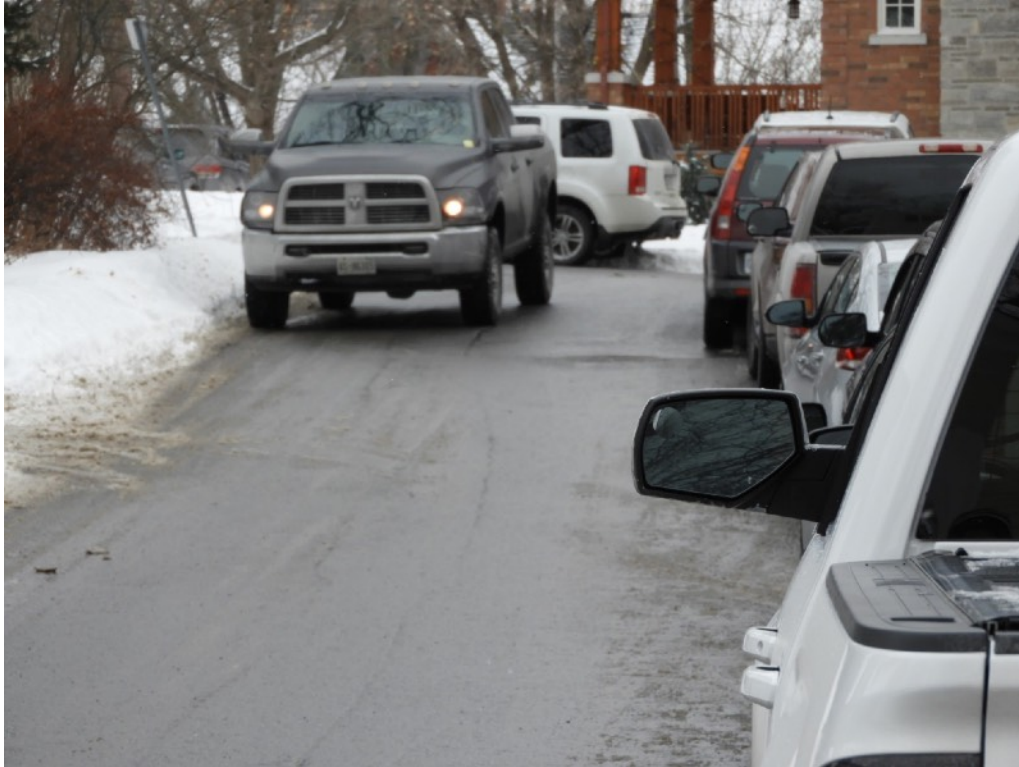
Walking on Dickinson between Mill and Tighe Streets is hazardous. Brave pedestrians have to dart in between cars to avoid being hit.

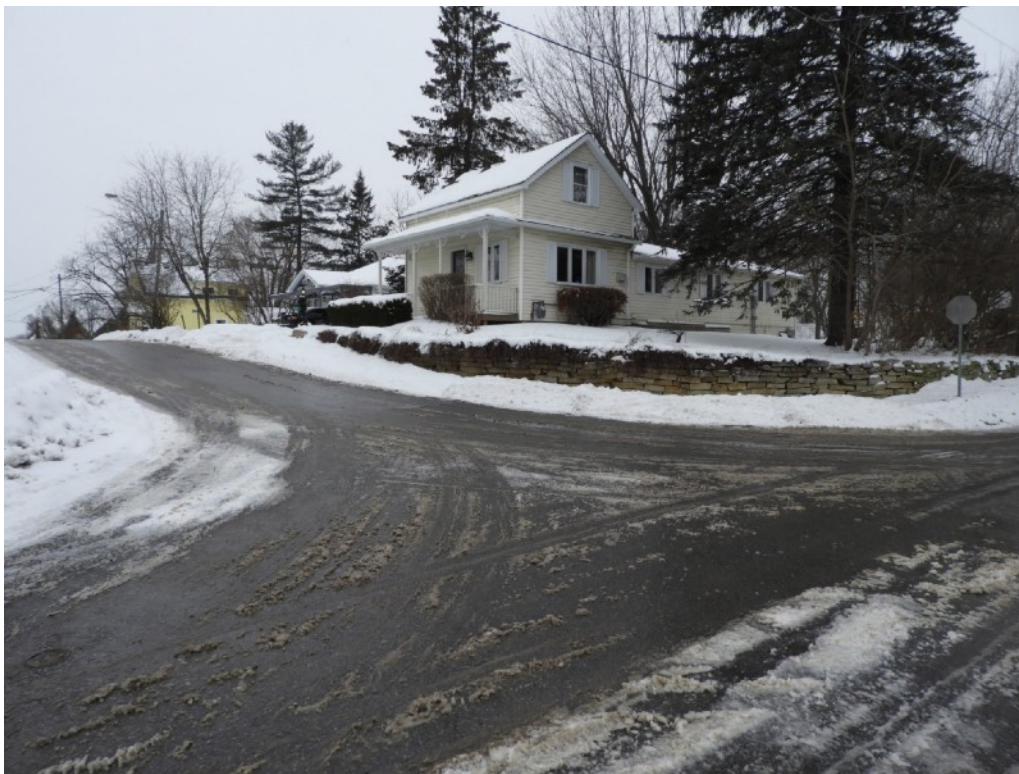
There is no stop or yield sign at the corner of Currier and Dickinson St.

Corner of Currier and Dickinson where there is no stop or yield sign to slow traffic.

Install a stop or yield sign

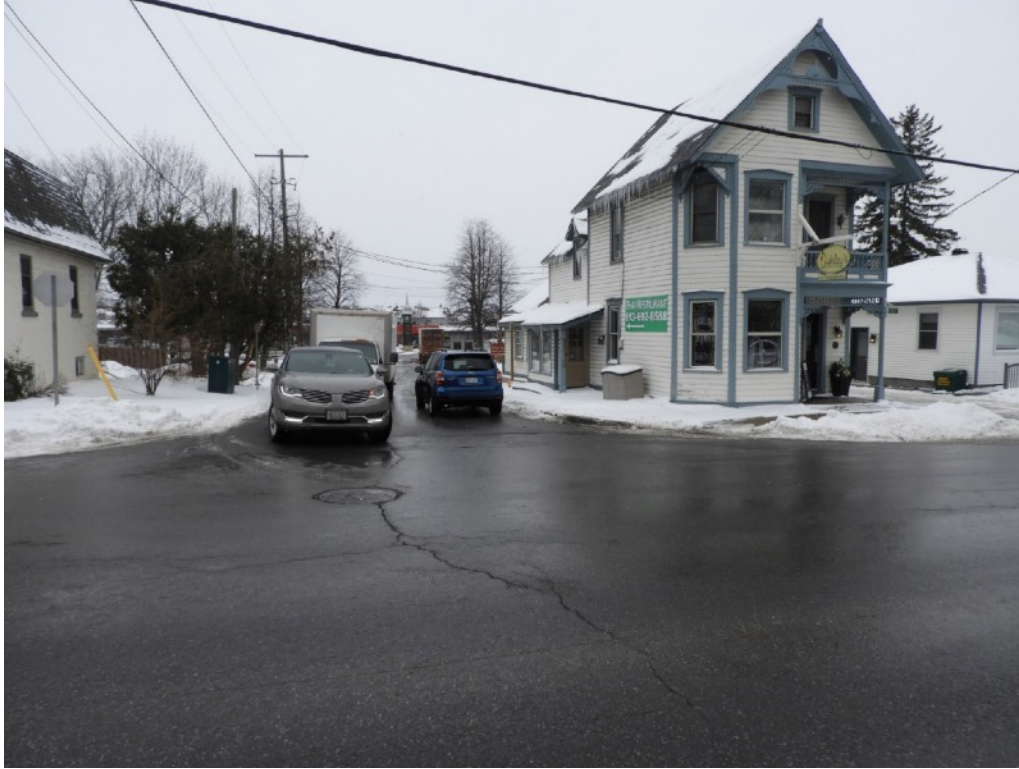
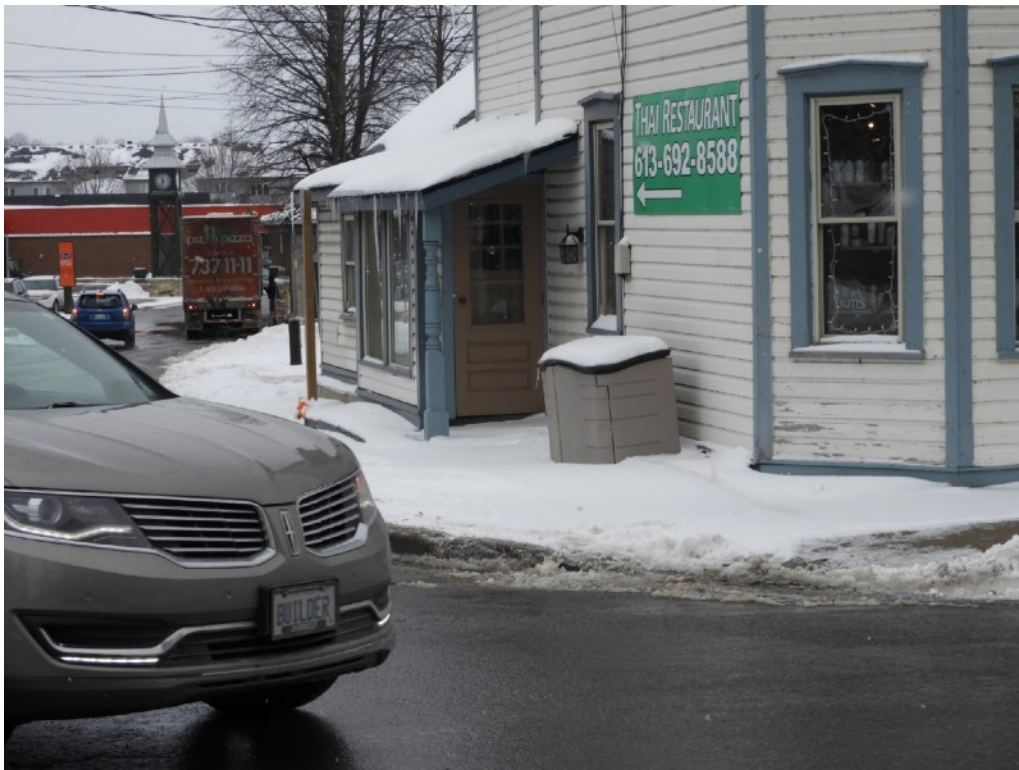
Currier St leading into the Mews is not passable. The only sidewalk is not shovelled and apparently private , the road is narrow and there is ice on the shoulders. It is perilous to use this as a pedestrian.

There is no public sidewalk in Currier into the Mews. This is a very busy corner, likely the busiest second to Main and Bridge and the most dangerous as there is no sidewalk, cross walk or stop signs.

Sidewalk be installed .

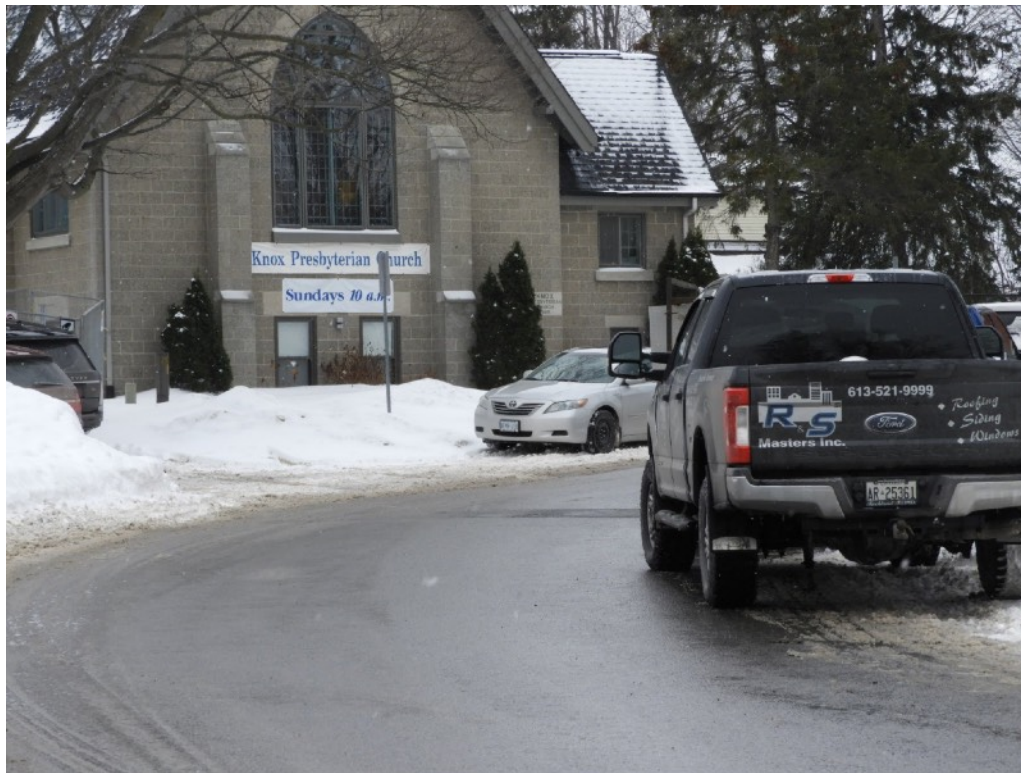
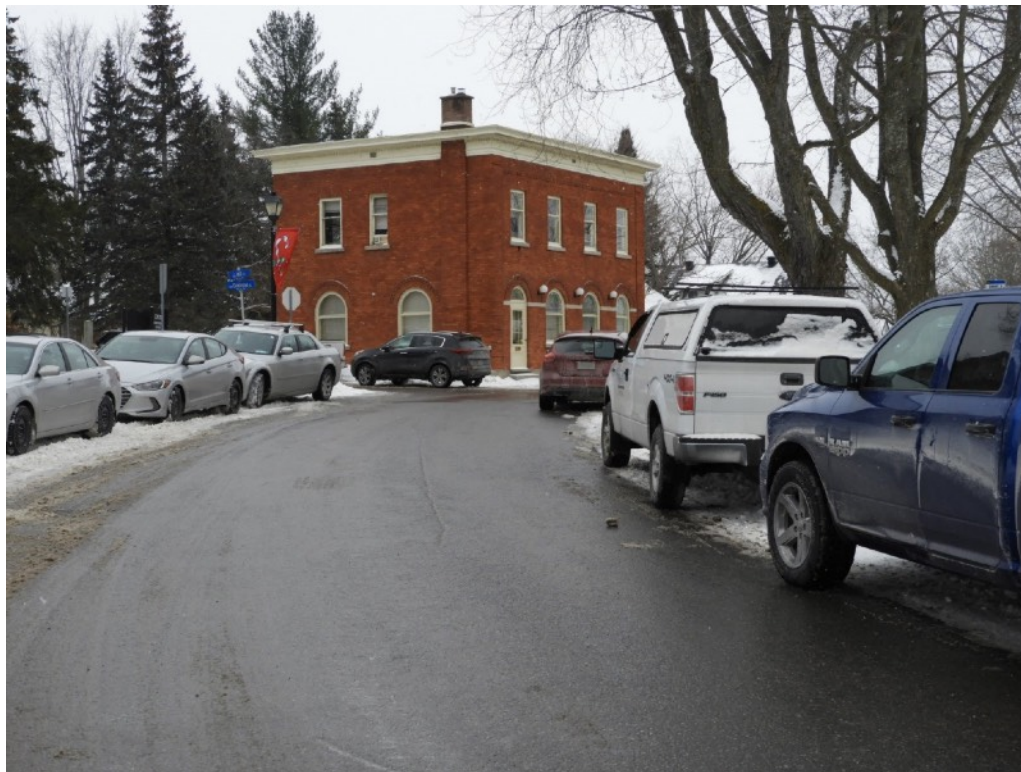
Traffic along Dickinson St pass the Mill towards the ROSSS building travels too fast. There is parking allowed on both sides of the road thus creating more safety issues especially in the summer with more people and children in this area. As well this route is used as a cut through by drivers wanting to avoid the lights and traffic at Bridge and Main St.

Dickinson St in front of the Mill. Parking on both sides , no sidewalks and cars going too fast is dangerous.

- a. Install 3 way stop signs at the corner of Dickinson and Mill St.
- b. Ban parking on one side of the road
- c. Request more of a police presence to enforce the speed limit.
- d. Traffic calming measures be considered

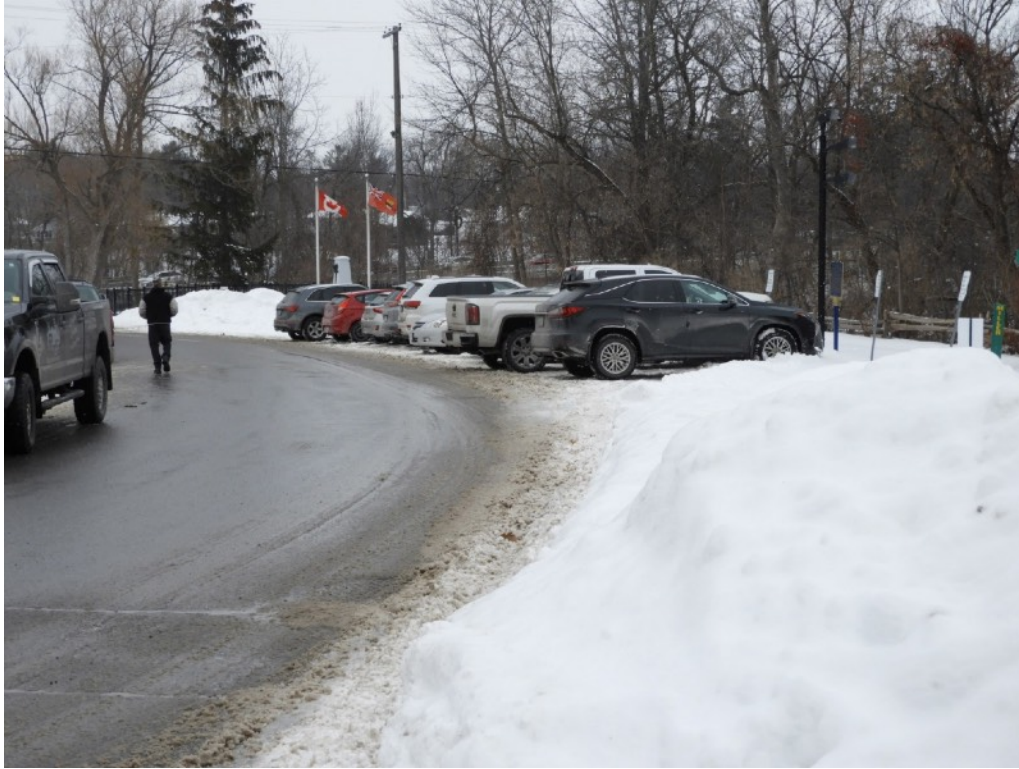
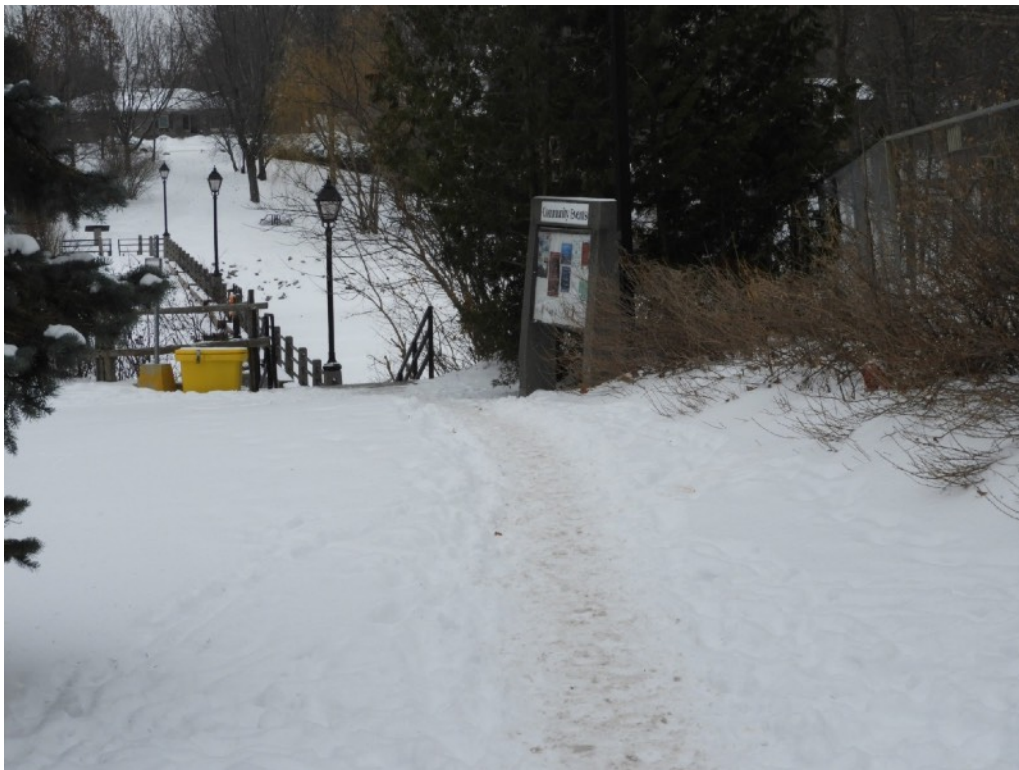
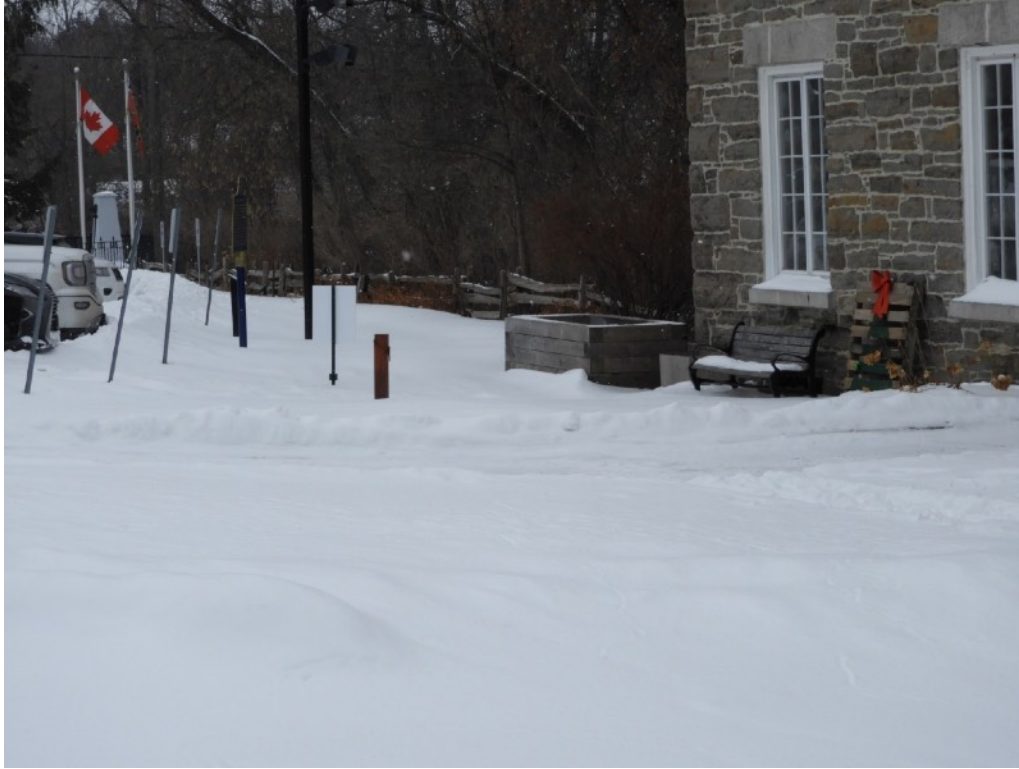
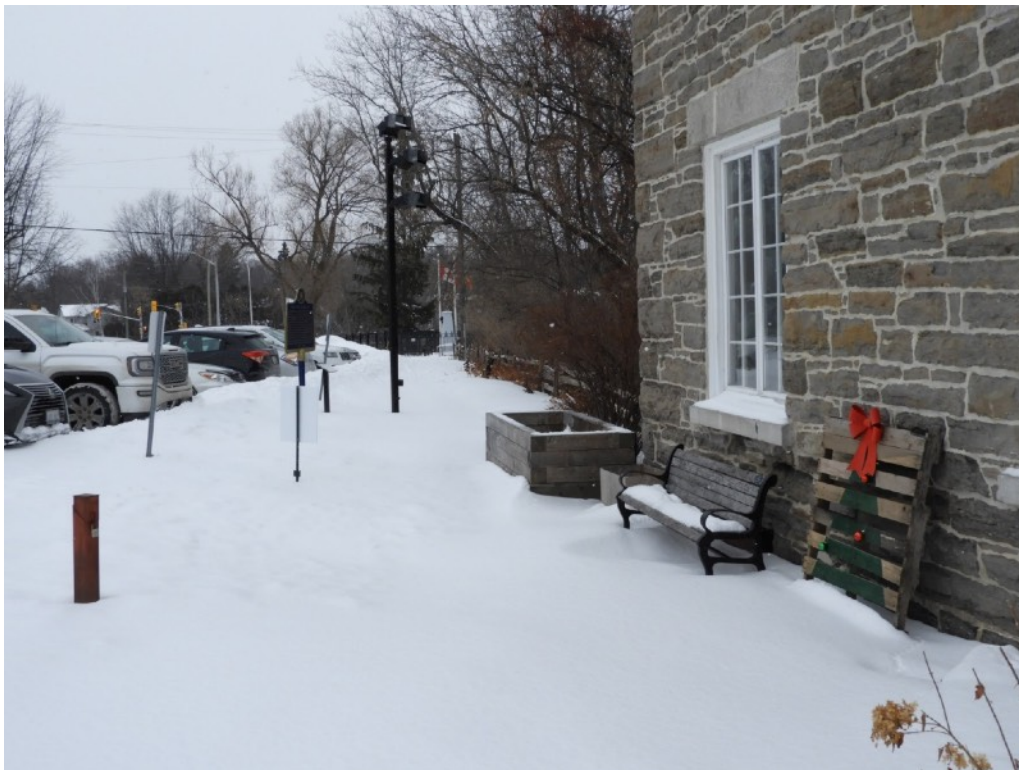
The sidewalk in front of the Mill is not shovelled forcing pedestrians to use the road

The city clarify who has the responsibility for this walkway and action.

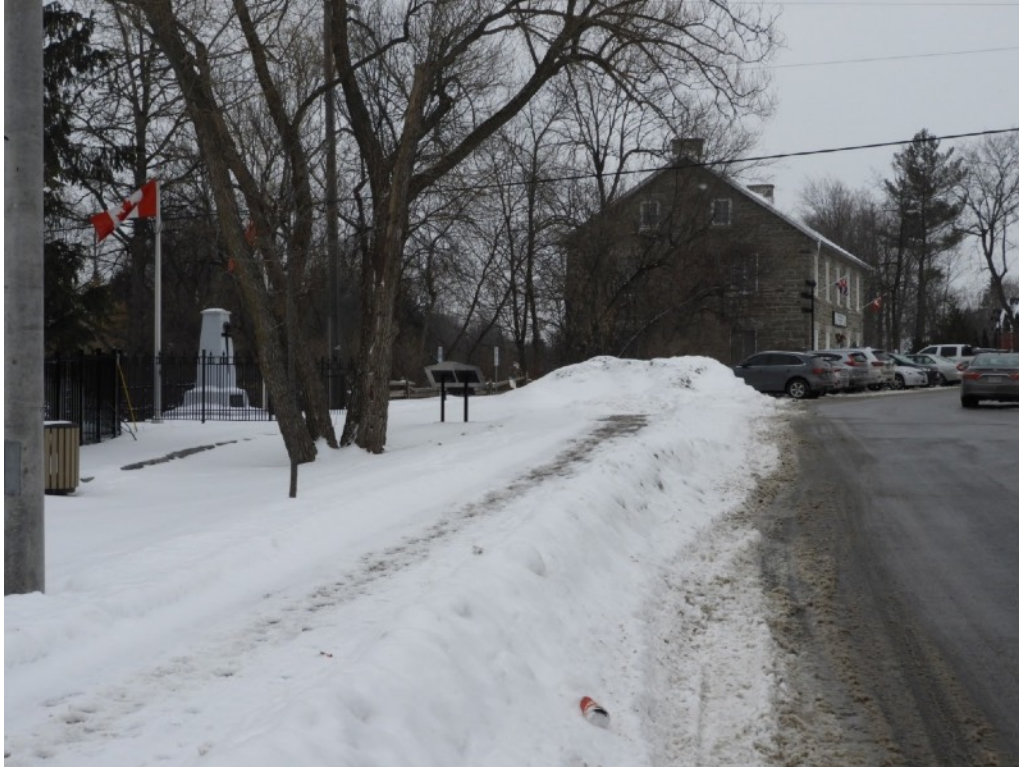
The shovelled sidewalk along Dickinson from Bridge St ends at the War Memorial The walk way beside the Mill is not shovelled at all. Our Public Works advisor stated that this sidewalk from the War Memorial to the Mill is the responsibility of City Parks not Public Works. There is no alternative but to use the road which is hazardous.

Sidewalk on Dickinson St towards the Mill ends at the Memorial forcing pedestrians to use the road jumping over a snow bank

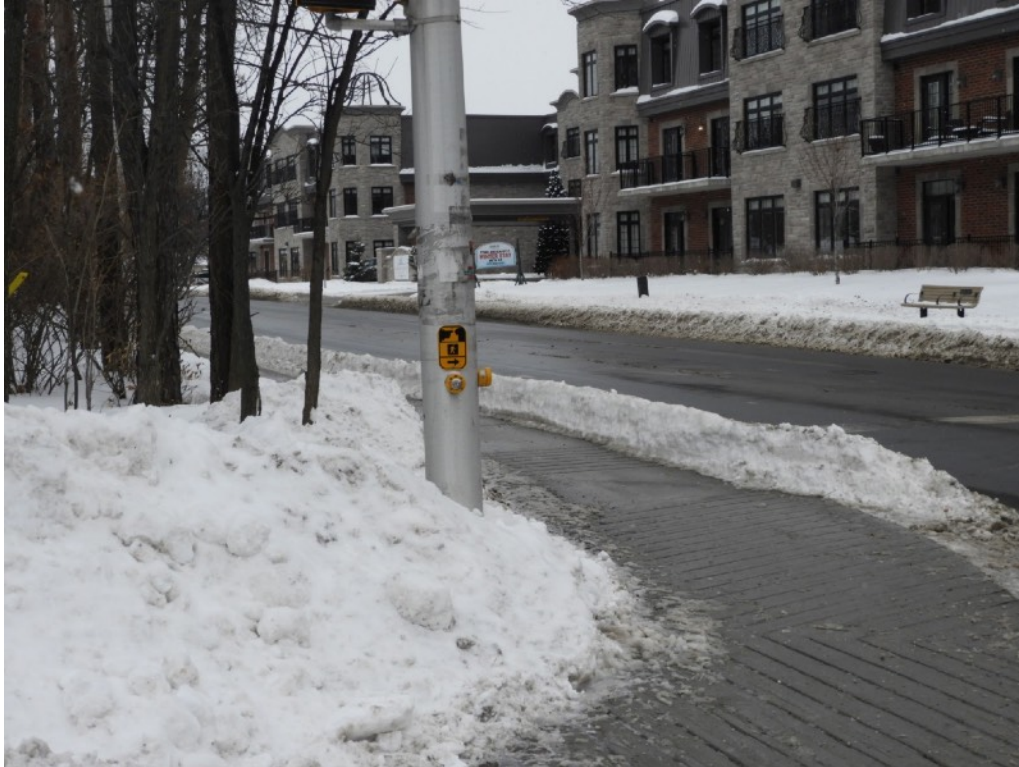
- b. The pole itself was covered with deep snow preventing a mobility impaired person from using the signal button.

Traffic signal light is not accessible

- a. Install audible signal devices
- b. City staff to clear around the pole.

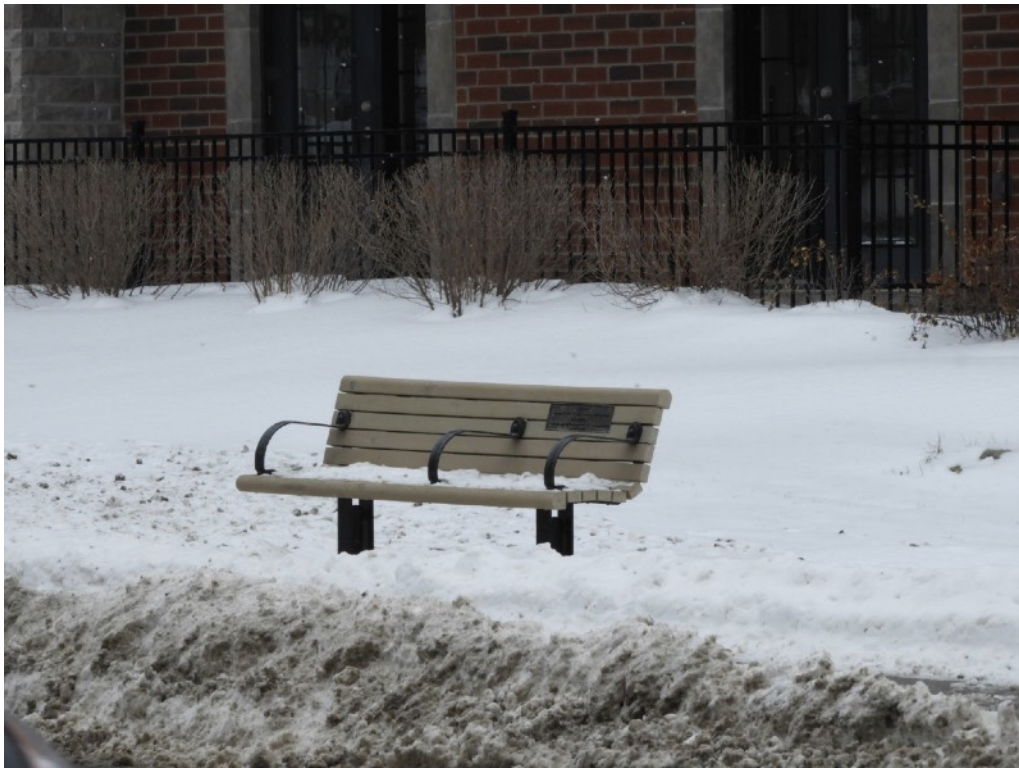
There are three benches: on Main St , in front of the Mill and in front of the Manotick Retirement Residence. All were snow covered. It is unclear who is responsible for maintaining these

One of three benches on the route which is snow covered

Clarify responsibility and request Mill to keep theirs cleared of snow.
