The Hunt Club Community Organization (HCCO) partnered with the *Council on Ageing* to do a walkability survey in Hunt Club. The community association's area of concern is the area bordered by Hunt Club Road, Riverside Drive, the Airport Parkway and the railroad tracks crossing McCarthy Road. We had 11 participants including representatives from the Council on Ageing, the City of Ottawa Transportation division and the local newspaper, the Community Voice. The day of our walk was sunny, with a temperature of around -5 Celsius but was held after a weekend of snowfall and freezing rain. Therefore, we encountered slushy and icy conditions.

Walkability Survey Routes

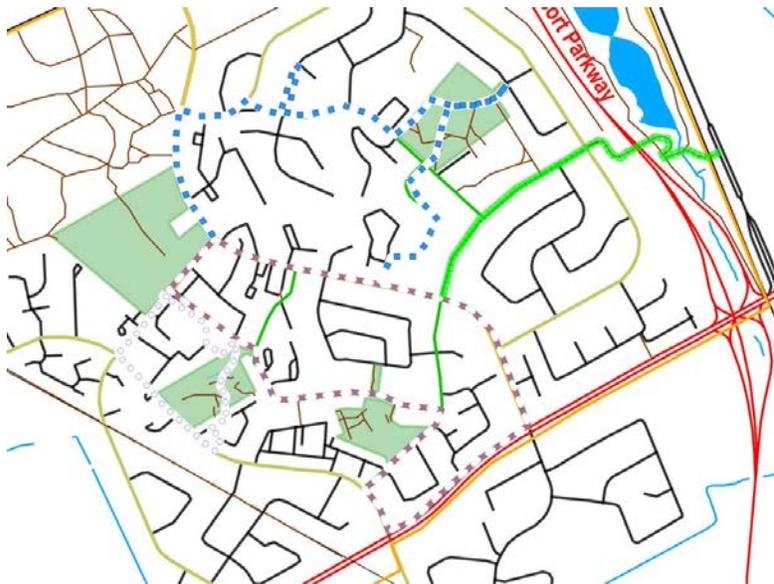
We set out from and finished at the Hunt Club Riverside Park Community Centre (3320 Paul Anka Drive) and covered 4 different routes:

- McCarthy Rd, Cahill Dr. West and the Airport Bridge to the South Keys Transit Station (Appendix A – green line on map)
- Paul Anka, Uplands Drive, Shearwater Court, Paul Landry Park through to the Hunt Club Centre parking lot (Appendix B – white squares on map)
- McCarthy Rd, Hunt Club Rd, Uplands Dr., Cahill Dr. West (Appendix C – brown squares on map)
- Plante Dr., Owl Dr., Pigeon Terrace (Appendix D – blue squares on map)

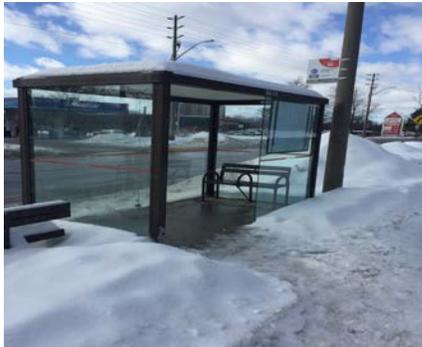
Generally, public transit stops were not well ploughed neither were sidewalks and curbs cleaned sufficiently to enable persons using mobility vehicles (powered wheel chairs and scooters), walkers or canes or for the visually impaired to navigate the sidewalks. In fact one of our auditors using a motorized wheelchair had to drive on McCarthy Road and the rest of his survey route because he kept getting stuck in the slushy sidewalks and on the curbs to get onto the sidewalks. However our survey took place after a weekend of snowfall and freezing rain.

**Snow covered Bus Stop**

The major issue for safety and accessibility for all persons, whether mobility or visually challenged or aged, was improperly cleared sidewalks and curbs which could result to an inability to walk or ambulate safely to access mailboxes, transit stops, the community centre or the shopping mall. Accordingly, we recommend that the City accelerate the time to clear, salt and sand sidewalks after inclement weather events. This is necessary if we are to encourage elders to stay in their homes as long as possible and is key in making Ottawa an age-friendly city.

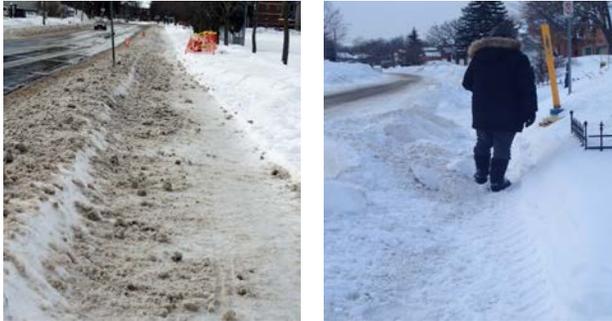
Although the sidewalks had been initially ploughed on Uplands Drive, Twyford, McCarthy and Cahill Drive West, the city street plough went by and sprayed wet slush over many of the sidewalks, burying them.

**Sidewalks buried with slush by City Street plough**

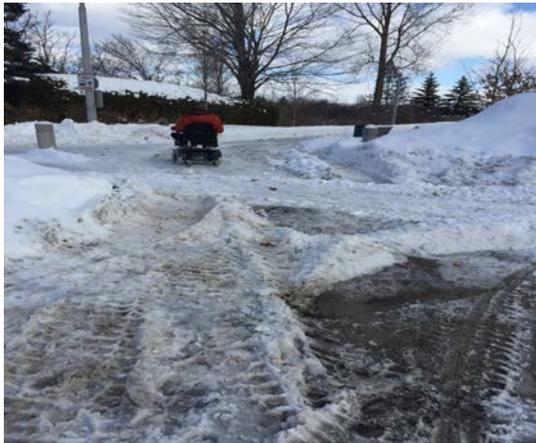
**Snow covered entry to pathway to the pedestrian bridge over the Airport Parkway**

Signage is needed on McCarthy, Cahill Drive West and Plante Drive to direct pedestrians to the pedestrian bridge over the Airport Parkway, the pathways around the settlement ponds, and the South Keys Transit Station.

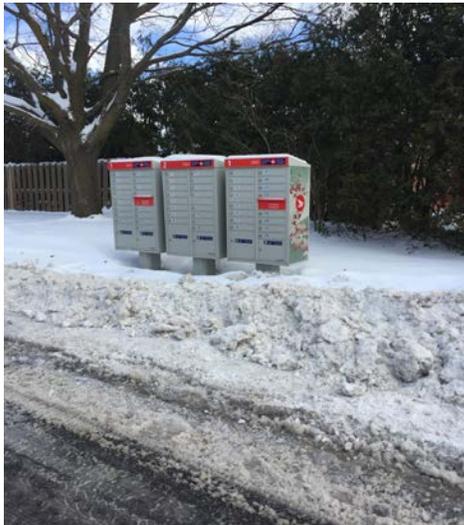
The major issue was snow-covered sidewalks; slushy curbs and inaccessible community mailboxes due to snow build up. This makes accessibility a challenge for mobility or visually impaired persons as well as the frail and elderly.

**Inaccessible Mailboxes**

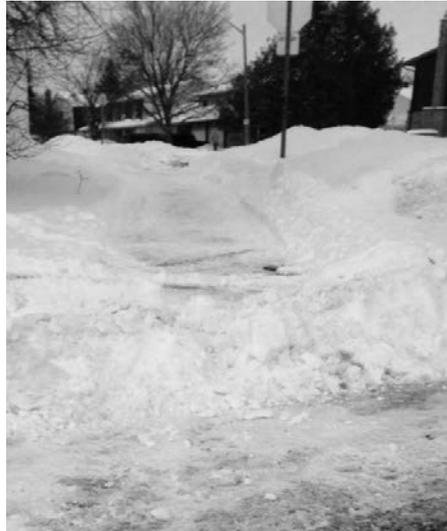
As an example, the sidewalk on the west side of McCarthy Rd between Paul Anka Drive and Hunt Club was improperly cleared of snow, not salted, quite icy and would be an impediment to any person who is visually impaired or mobility challenged and using a wheel chair, walker or scooter.

**Snow covered curb**

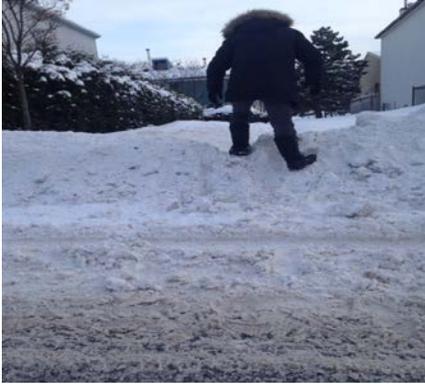
- Path between 166 and 170 Twyford to the Hunt Club Centre parking lot and mall has high traffic use but was not cleared at all in order to accommodate mobility or visually challenged persons

**Un-ploughed pathway**

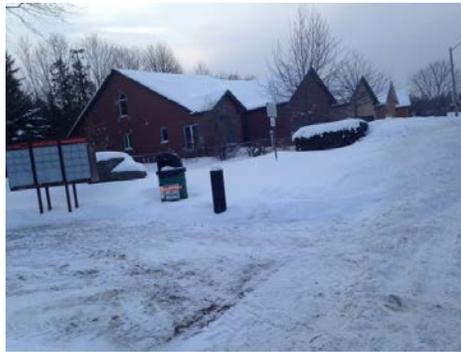
- No cross walk curb cut or pedestrian diagonal painted lines at stop on Cahill Dr. West at Twyford.
- Community mailboxes on Twyford at Cahill Park play structure are backset 15 feet without a curb cut.

**Mailbox set back 15 feet with no curb cut**
